FRED  
MEYER

BUILDING ADDRESS 5425 CHINDENBUILDING DESCRIPTION FRED MEYER - (GROCERY- DEPARTMENT- GARDEN- HOME IMPROVEMENTS)TILT-UP SLAB AND LIGHTWEIGHT T.J. ROOF CONSTRUCTIONGPM's 170,980 FT<sup>2</sup>

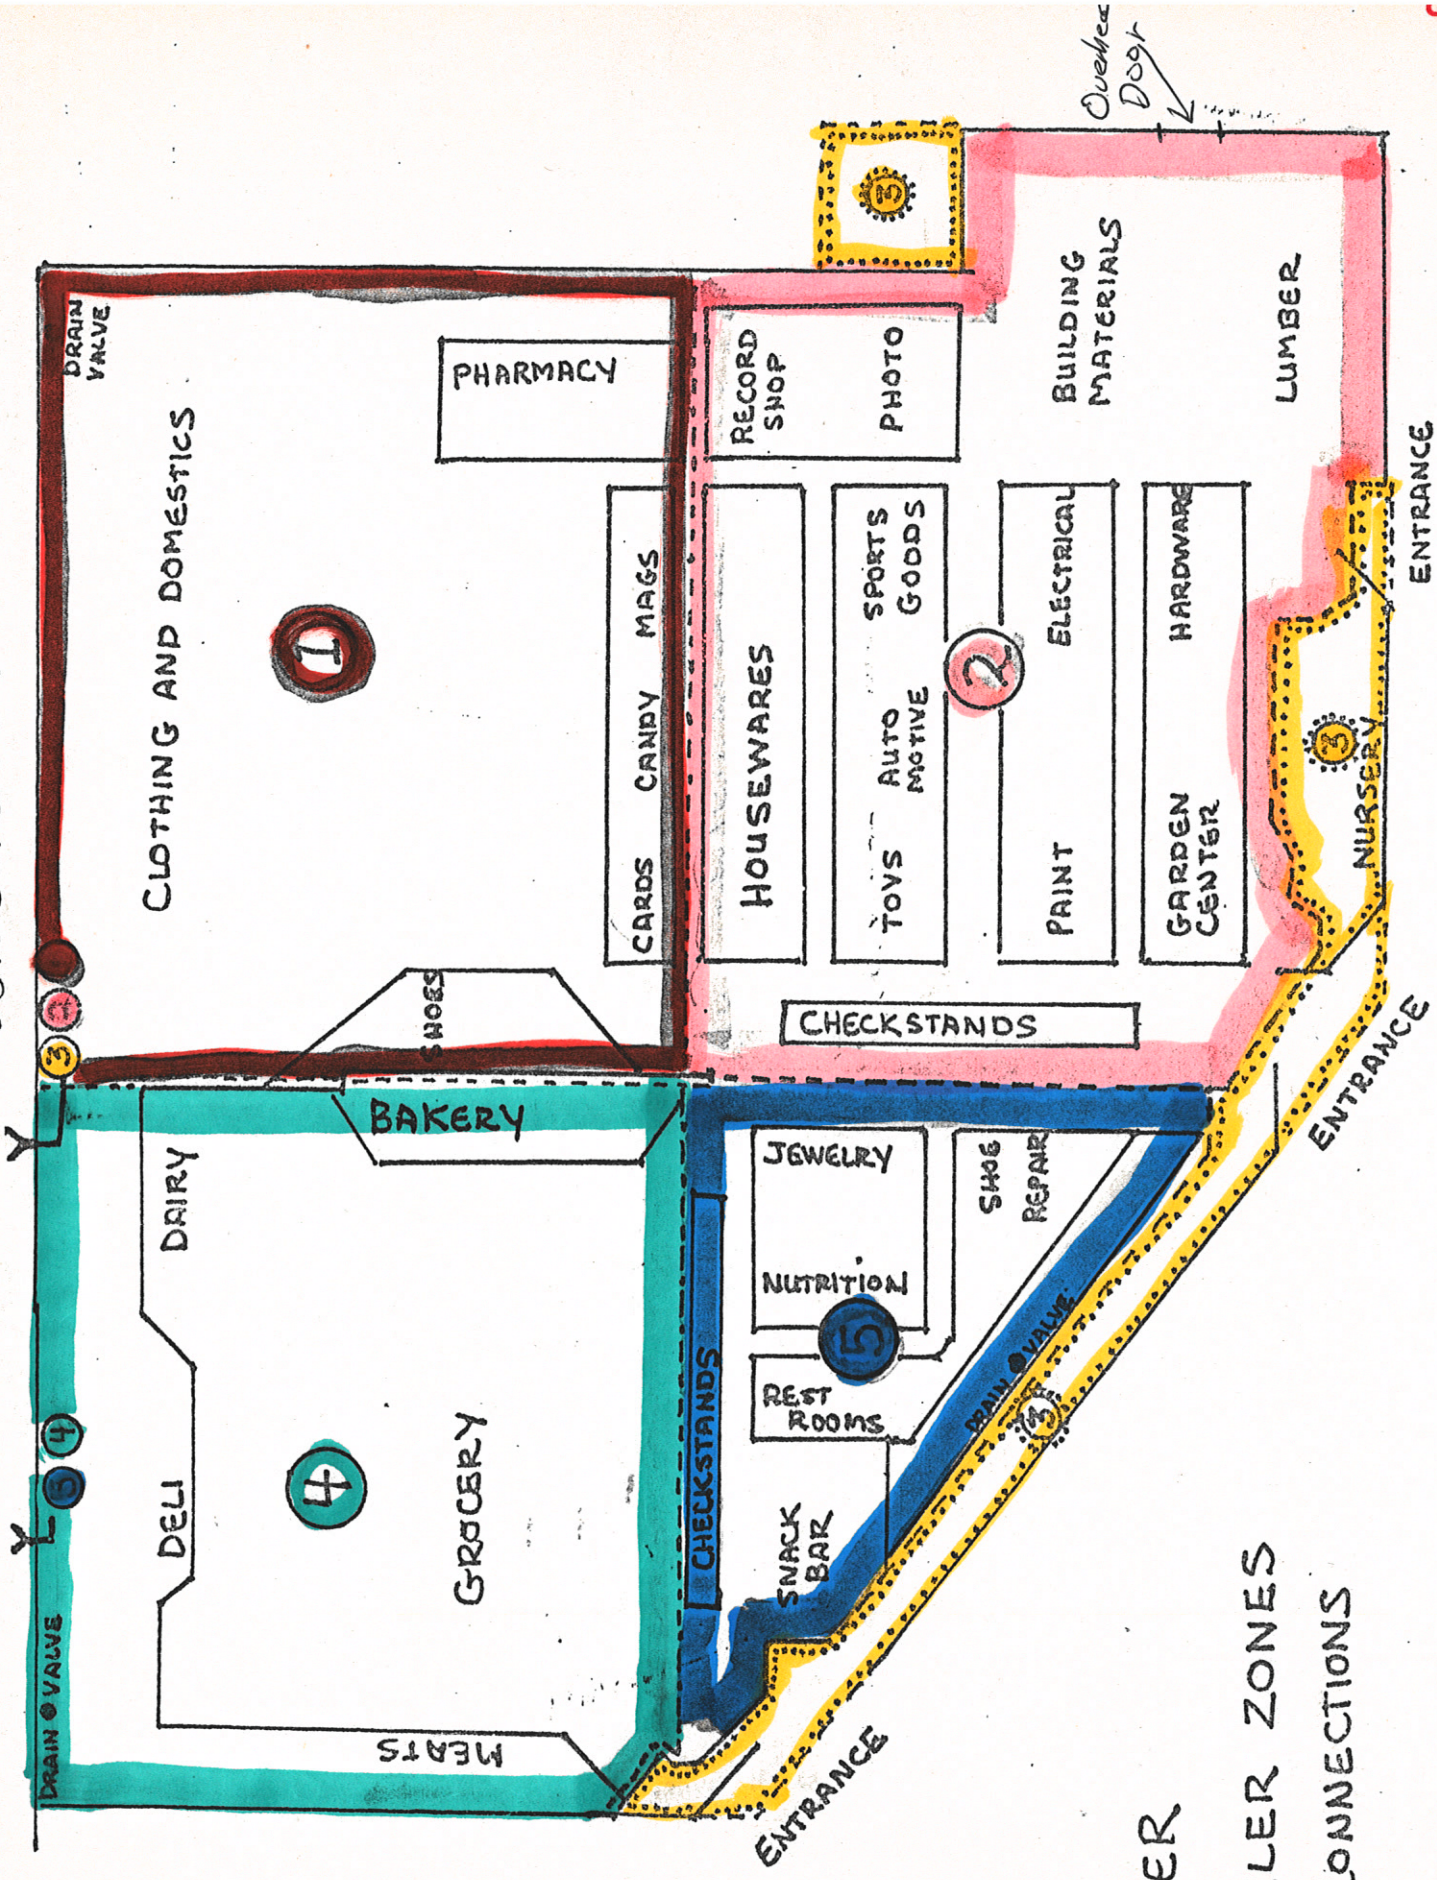
#31s DRY SYSTEM

SPRINKLER ZONES  
AND CONNECTIONS

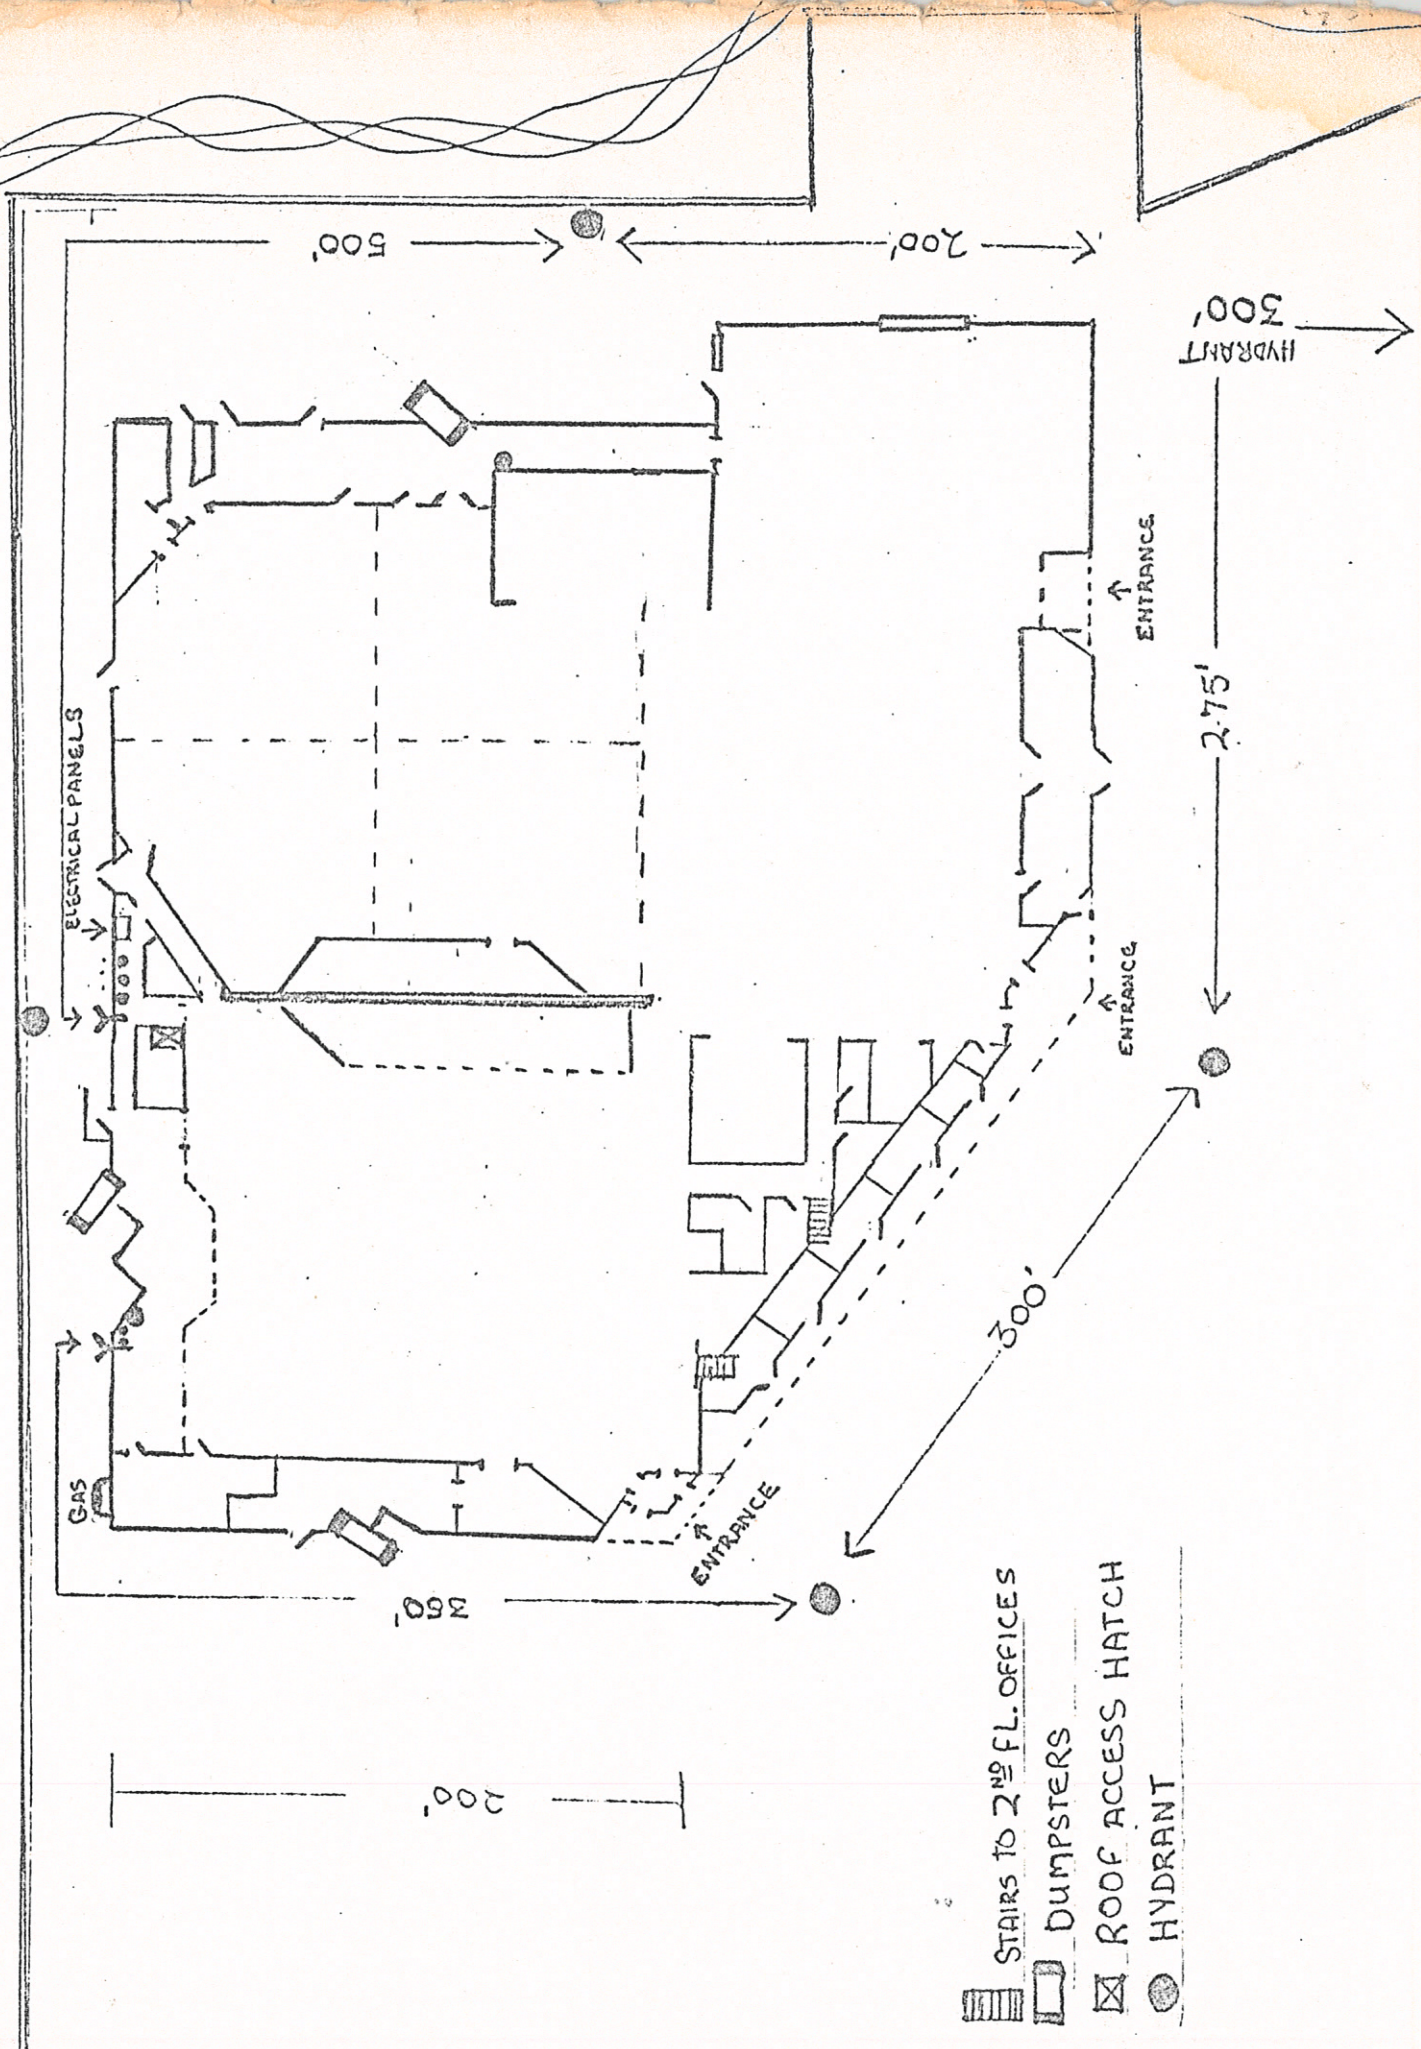
# FRED MEYER FLOOR PLAN

STAIRS TO 2ND FL. OFFICES
-

DUMPSTERS
-

ROOF ACCESS HATCH
-

HYDRANT

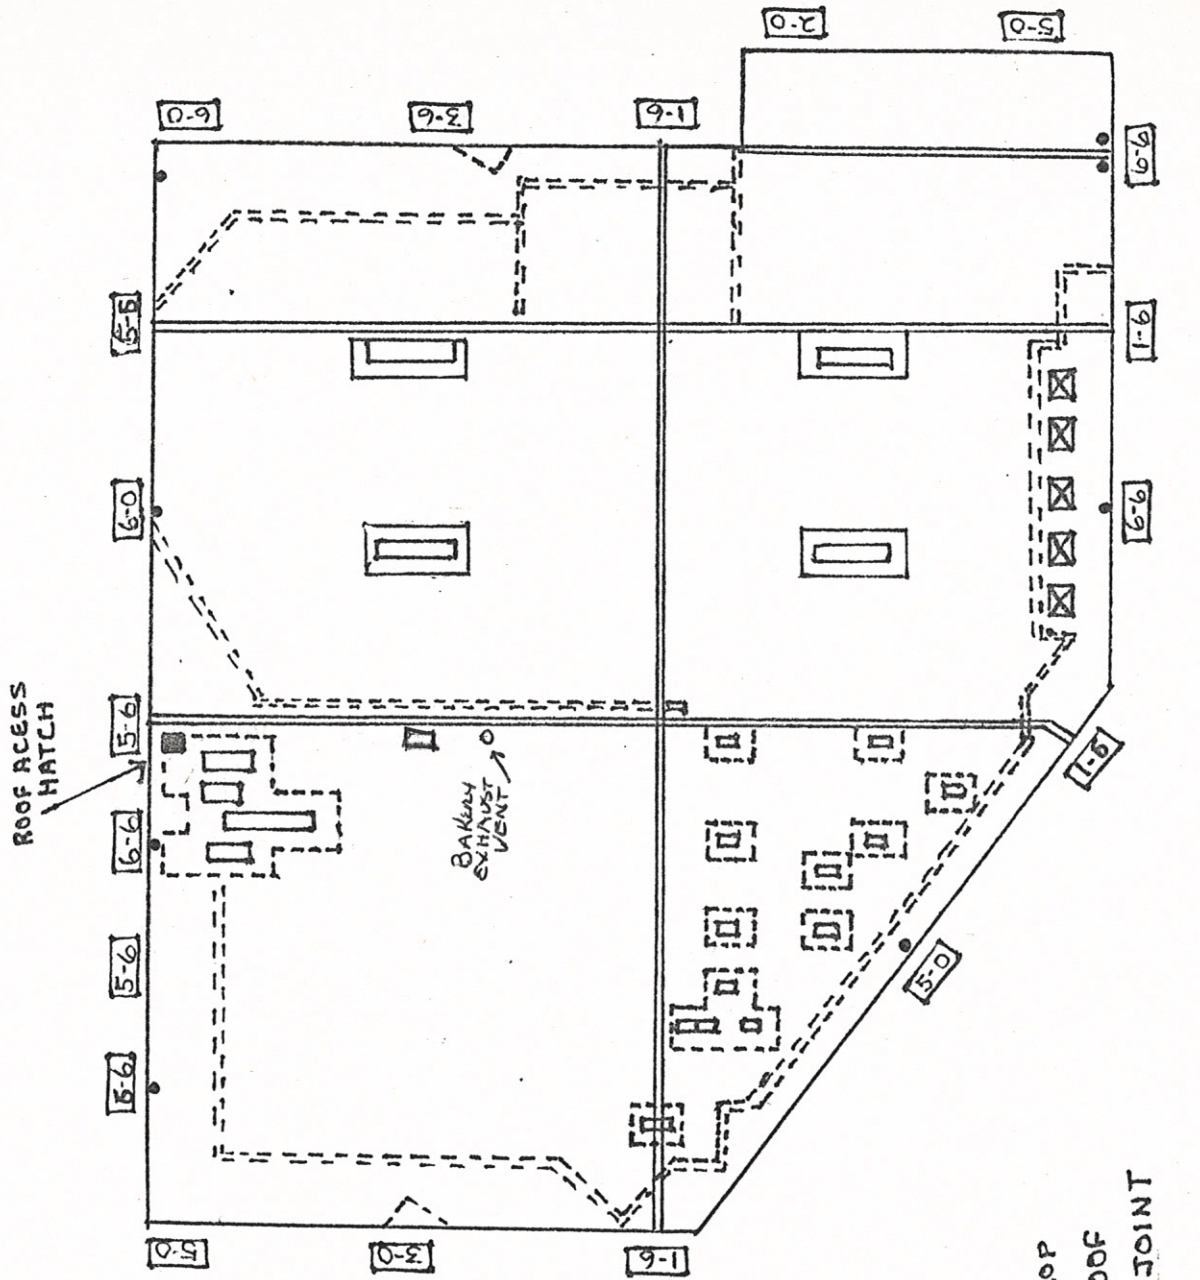
# FRED MEYER ROOF PLAN

TOP OF PARAPET 27'-5"

□ INDICATES VERTICAL DROP

FROM TOP OF PARAPET TO ROOF

— ROOF DRAIN CONTROL JOINT

☒ SKYLIGHTS

===== LINE OF WALL BELOW

HAZARDS TO PERSONNEL DISORIENTATION - STRUCTURAL MAZE - EARLY ROOF COLLAPSE  
2<sup>ND</sup> STORY COMPRESSOR ROOM DOOR HAS ABRUPT DROP-OFF. - UP TO 6 FOOT  
DROP FROM PARAPET TO ROOF
