# "SUN-LINER MOTEL"

3433 CHINDEN BLVD

QUICK ACCESS PREPLAN FORM

BUILDING ADDRESS 3433 Chinden Blvd.

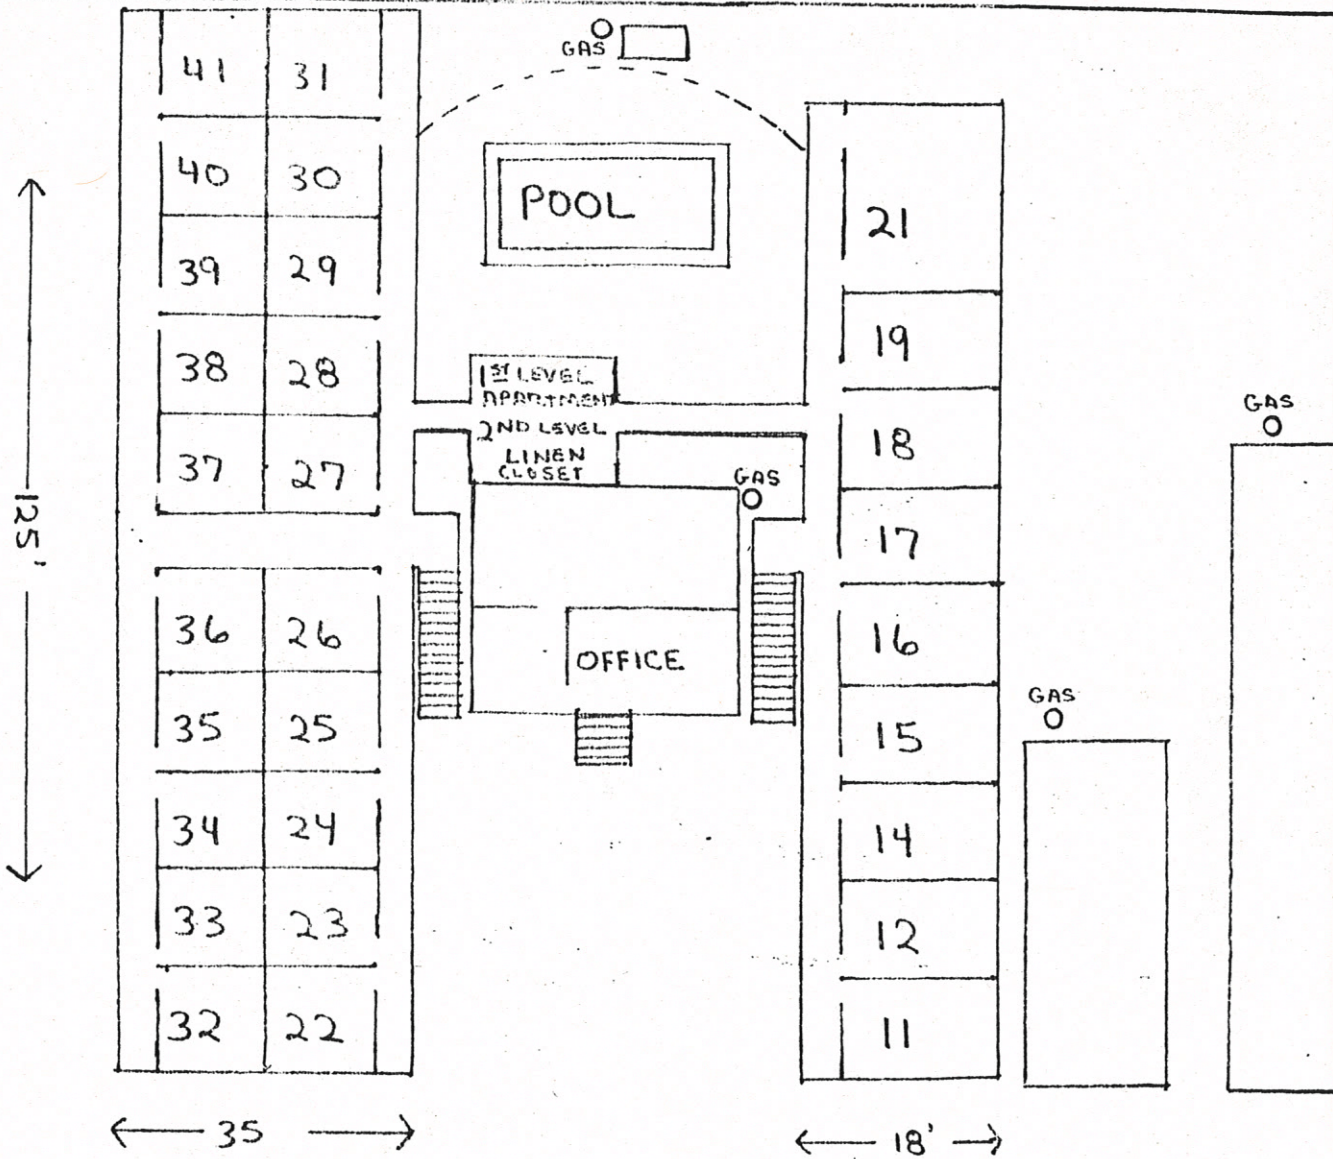
S-2

HYDRANT  
34TH + BROWN  
400'

HYDRANT  
35TH + BROWN  
350'

STOCKTON (ALLEY)

CHINDEN BLVD

HYDRANT  
34TH + CHINDEN  
250'

HYDRANT  
35TH + CHINDEN  
300'

BUILDING DESCRIPTION Metal sided wood Frame single  
story Motel - elevated 8 feet with parking  
underneath no attic space above rooms

HAZARDS TO PERSONNEL early collapse due to open web  
floor construction supported by glue laminated  
beams with concrete pillars
